THE NUMURKAH TORNADO OF AUGUST 1964

By E. F. Phillips

Central Office, Bureau of Meteorology, Melbourne

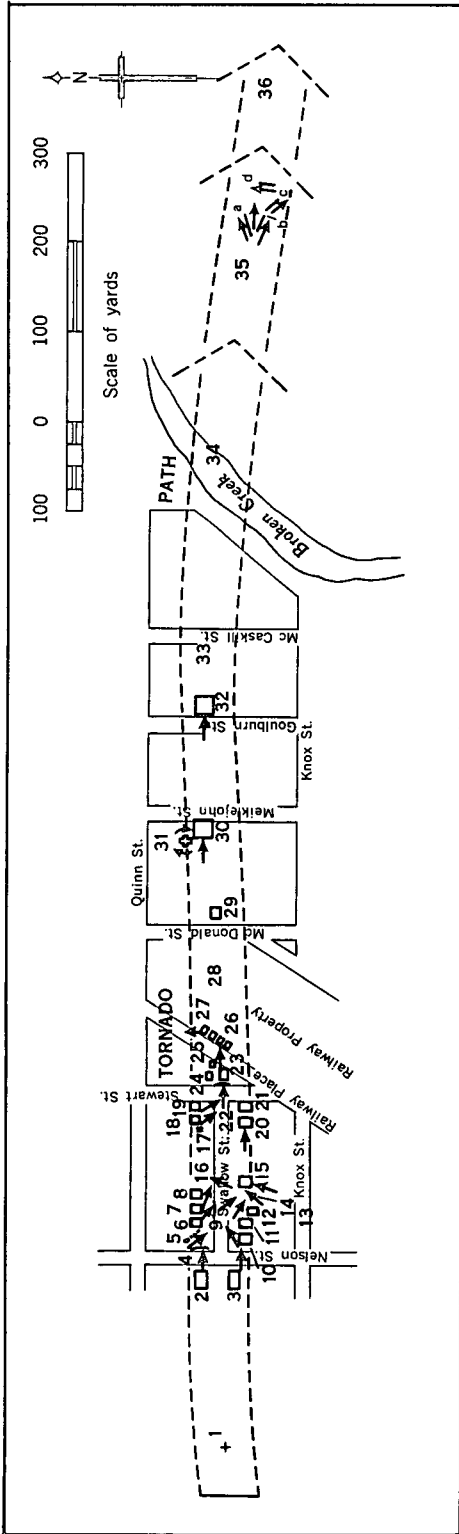
The wind damage varied considerably along the path of the tornado which was approximately 200 to 300 feet in width (for tornado path and directions in which debris were blown see Fig. 1). A description of the damage is in Appendix 1. The lay of the damage enabled the determination of the likely wind flow which was mostly in the direction of movement of the tornado, but there were occasions when there was evidence of winds blowing in towards as well as out from the tornado path, suggesting that strong rotation of winds was taking place in the funnel. This is supported by eye-witness accounts of galvanised iron roofing sheets seen spinning in the funnel, some 200 to 300 feet above the ground, like pieces of paper in a whirlwind. The strength of the winds in both the vertical and horizontal can be gauged from the following:-

Fig. 1 Map of tornado path through Numurkah. Arrows indicate the direction of debris.
(For description of damage at numbered locations see Appendix I)

Position No. in Fig. 1	Damage
1	Tall tree stripped of upper branches at a height of about 40 feet above the ground.
2	House, garden and fence undamaged - only effect of storm was to blow off a wind guard on top of chimney at height of about 20 feet.
3	Petrol bowsers slightly damaged.
4	Barbed wire fence blown down.
5	A tree about 4 feet in diameter which was leaning to the north was blown down in a SE direction.
6 to 8	A flat roofed house had its roof lifted vertically off; the two chimneys through the roof were unaffected. This roof smashed the chimney on the front of the house 7 and finally crashed into house 8. Both houses 7 and 8 received wind damage to their roofs in the front.
9	The strong picket fence of house 7 was blown outwards towards the road.
10	House unroofed and badly damaged and leaning in the direction taken by the tornado. Also its fence on the east side, i. e. along Nelson Street, blown inwards.

11	Front half of house unroofed. Tin from the hip roof flew over house 12, hit ground in open allotment at 13 and still with battens attached finished against hedge 14 at the side of house 15. Iron from roof of house 11 was also detected embedded in trees on open allotment at 16 opposite house 15.
12	This house was very old and in a poor state of repair but received no damage as it was set back about 30 feet further from the road than the neighbouring houses. Damage was much less about the middle of Swallow Street and an old barn (17) was undamaged.
15	House received very strong winds blowing towards the front of the house. Fig. 8 shows house 15, next to vacant allotment, with trees at side of house leaning towards street whereas fence of vacant allotment is blown inwards, and iron wrapped around telegraph pole indicates a strong wind blowing off the road.
18	Other than damage to top of wall near front of houses, the TV aerial was sloping to front and in direction of tornado.

19	Tiled roof lifted, front fence bowed out towards the road.
20	House had its wall on the leeward side blown out about a foot at the bottom, suggesting that the house exploded.
21	Front of house unroofed.

Position No. in Fig. 1	Damage
22	Tin fence blown inwards.
23	House very severely hit and completely unroofed (see Fig. 9). Lady of the house reported that before the roof was lifted off, the carpets and linoleum rose several feet off the floor. A 4 in. by 2 in. batten of hardwood, with galvanised iron attached, was speared into the top of the back wall of wire netting and concrete which faces to the north. (See hole above back door in Fig. 9). The rotary hoist is leaning to the west and the tree on the right to the east. Thus the wind blew from north, west and east, suggesting a vortical circulation of very small dimensions.
25	A garage was located here. Eye witness described that the garage roof was lifted over the telegraph wires in Railway Place.
26	Three railway houses of breeze brick, all of which lost their roofs. However, their front fences and the trees on the footpath were undamaged, suggesting that the tornado was most destructive some 10 feet or more above the ground.

27	Some roofing material removed and the top of the gable on the south was pushed towards the north.
28	In railway station ground no damage was evident and further along the tornado's path, in McDonald Street, damage was relatively minor.
29	Lost part of roof.
30	Powells' engineering store, a large tin shed 66 ft by 72 ft well constructed with 3 in. iron pipes for uprights, was severely damaged. At the back of the store, which was directly in the path of the tornado, these pipes were bent inwards whereas at the front of the store two blocks of cement of 28 in. x 28 in. x 36 in., which were buried in the ground and in which the iron pipes were embedded, were lifted out of the ground.
31	A roof of a well-built brick garage was lifted off and dropped at right angles to its original position which was in the direction of the tornado path. This suggests that the wind was strongly rotating.
32	A girl was blown through the window of Bitcon's store and a small detached building at the back of Telegraph Hotel was torn apart.

33	Very little evidence of damage here.
34	The tornado sucked up water from Broken Creek to form a water spout.
35	(a) At this position about three miles to the east of Numurkah, A peppercorn tree, 5½ feet in diameter near the base of the main trunk and about 50 feet high, was blown out of the ground;

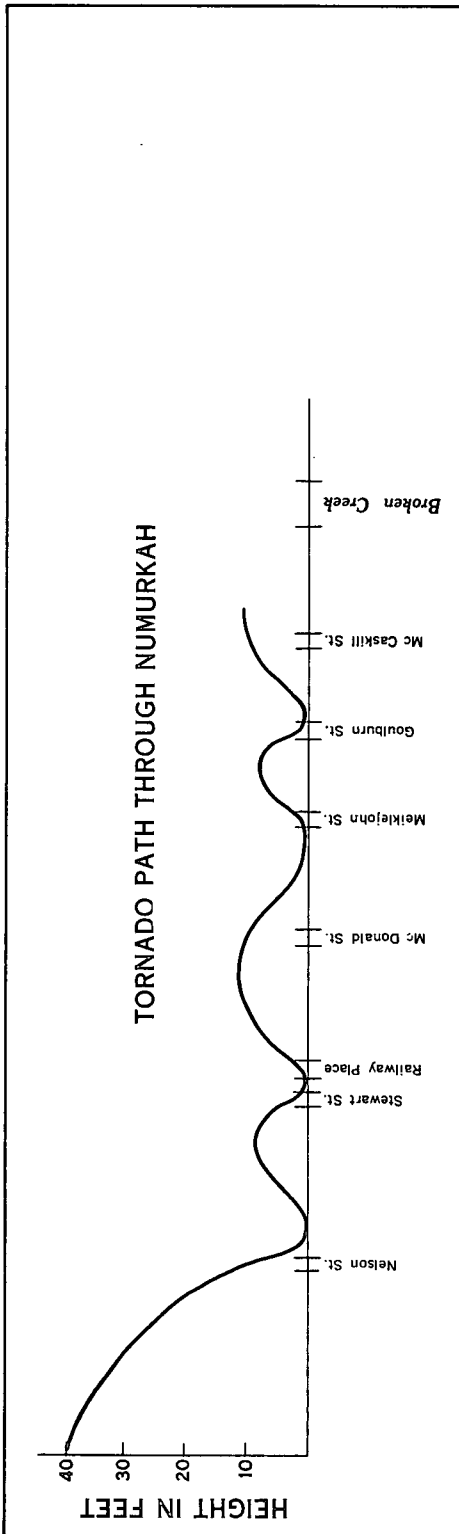
The height above the ground at which severe structural damage occurred varied considerably along the tornado path. Skip areas were evident between the areas of heavy destruction. Fig. 2 shows a graph of the lowest height at which there was severe structural damage along the tornado path through Numurkah.

Fig. 2 Estimated lowest height at which severe structural damage occurred along the path of tornado through Numurkah.
