# Comparisons between topographically surveyed debris lines and modelled inundation levels from severe tropical cyclones *Vance* and *Chris*, and their geomorphic impact on the sand coast

Jonathan Nott

Graeme Hubbert

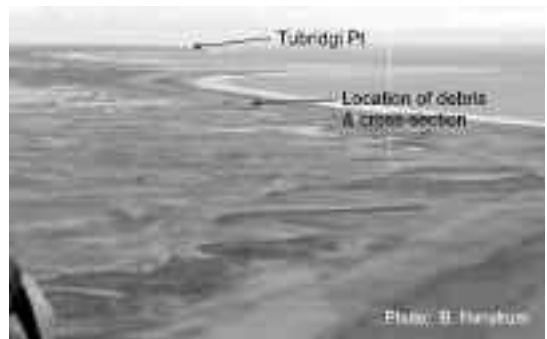
**Fig. 4** Oblique aerial photo of area shown in Fig. 3 near Tubridgi Point. Note the virtual complete removal of all three rows of dunes and the extent inland of sand splay and the complete removal of dune and hind dune vegetation.

Precisely where the zone of maximum winds struck, however, all three rows of 6 - 7 m high dunes (Fig. 3) were removed and the sand transported inland as an extensive splay approximately 400 - 500 m wide and 200 - 250 m deep (extending inland from the position of the former first dune row) (Figs 4 and 5). This sand splay decreased in thickness from 1.5 m at the rear of the position of the former third row of dunes, to 0.75 m thick at its most inland extent. The splay terminates abruptly at a salt marsh where it is marked by a steep-fronted (about 30° angle) toe slope. Sediments within the splay were deposited as steep (about 30°) tabular cross-beds (Fig. 6). Medium to coarse-grained sand occurs at the base of the unit, along with clasts of coral and shells, and grades upwards into medium to fine-grained sand. Lithic gravel measuring up to 25 cm across, were deposited in an imbricated position within the sand sheet inland of the position of the former dunes. (Imbrication is the depositional alignment of gravel or clasts where the particles lie against each other in a shingle-like pattern.) These gravel dip towards the ocean, showing they were deposited by an onshore flow. The marine inundation also generated scour pits within the sand splay. These pits measure up to 3 m wide and 1 m deep and occur on the lee (inland) side of tree stumps. The onshore flow was also able to carve channels 1 m deep and several metres wide over distances of several tens of metres (Fig. 7). These channels were carved by the onshore flow of water rather than by water draining from the land as demonstrated by the imbricated gravels in the sand floor of these channels. All of the vegetation including clumps of spinifex grasses, which dominated the low-lying salt marsh plain behind the former dunes, small trees (up to 3 m high), and bushes, were stripped from the land surface up to 300 m inland by this flow. Only occasionally did the dead stumps of trees remain, such as on the crest of an eroded knoll of the former foredune, or inland of the former dunes. Debris in these dead stumps show that flow depths were still at least 2 m, 150-200 m inland, and flow velocities were also high as gravel clasts were embedded within the debris at an elevation of 1.5 m above the present ground surface (Fig. 7).

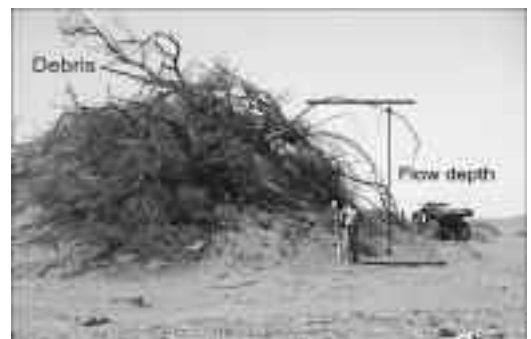
**Fig. 5** Remnant of dune near Tubridgi Point with debris in tree on crest of dune. Note depth of marine inundation. Dune is located at the rear of the beach, so the actual depth of marine inundation here is several metres greater than the height of debris above immediate ground level.

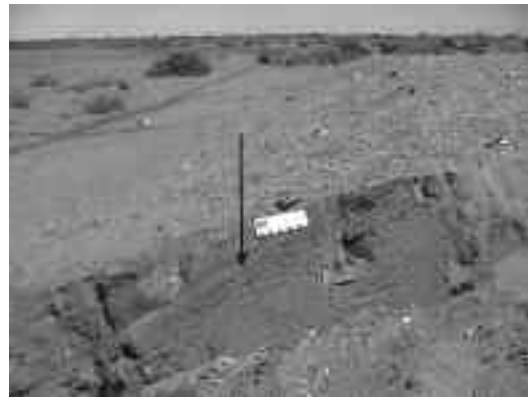
**Fig. 6** Tabular cross-beds in toe of sand splay/sheet 300 m inland. Cross-beds such as these indicate water laid deposits by a unidirectional flow of reasonably high velocity.

The extent of the sand splay, the tabular cross-beds, scour pits, and imbricated gravel suggest that the marine inundation generated by TC *Vance* near Tubridgi Point, struck the coast with considerable force and moved inland as a reasonably high-velocity bore. The presence of similar scour pits and erosional features in beach and dune sands have been determined empirically to occur when flow velocities exceed 4 - 5 m/s during the passage of tsunamis across sand barriers. Also, the fact that the flow was transporting lithic gravel clasts as suspended, or at least

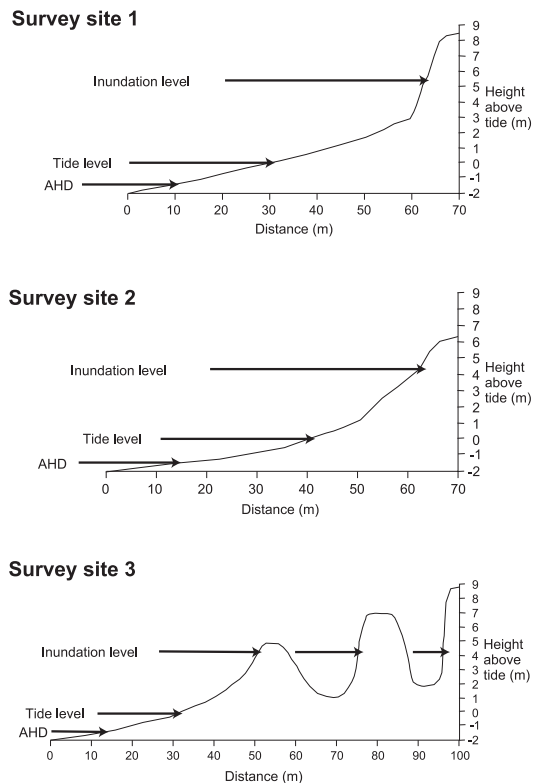
**Fig. 8 Cross-sections of beach and dunes impacted and surveyed debris heights generated by TC *Chris*.**

topographic surveys were then undertaken where the storm surge impact appeared to have been greatest. The results of these surveys are presented in Table 2 and Fig. 8. As with TC *Vance*, topographic surveys were undertaken using an electronic theodolite and electronic distance measurer. At only one location, site 3 was debris surveyed in a hind dune swale. This debris was emplaced following inundation of the foredune. It is this type of evidence that provides probably the most accurate representation of the height of the storm tide. Debris lines seaward of foredunes often reflect the extent of wave run-up. The surveyed height of the debris line at site 3 therefore, represents the most reliable indicator of the level of the storm tide or still water level during the event

The height of the debris lines varied between survey sites. In Fig. 8, these heights are presented relative to the tide level at the time of landfall of TC *Chris*. The debris at survey site 1 was 5.4 m above the level of the tide at the time of cyclone crossing, 4.1 m at site 2 and 4.2 m at site 3. It is likely that wave run-up has contributed to these heights at sites 1 and 2. The extent of the wave run-up contribution can be estimated by making comparisons between the height of the surveyed debris lines and the predicted surge heights from numerical models.

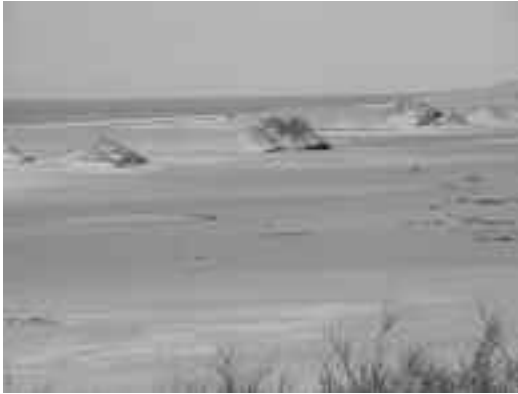
**Fig. 10** Eroded foredunes at survey site 3. Marine inundation overtopped foredunes with resultant vertical erosion and removal.

Based upon the extent of erosion of foredunes, the maximum surge appears to have occurred along a 500 – 700 m stretch of coast located adjacent to survey site 3. As discussed, this section of coast lies close to the modelled estimate of the location of likely maximum surge, and also the likely location of maximum winds from interpretation of the cyclone crossing point as shown by Bureau of Meteorology radar imagery. Dune erosion appears to have been greater here than elsewhere along the coast. At each of the other survey locations (sites 1 and 2) dune erosion occurred in the form of scarping i.e. there was erosion of the seaward face of the dunes resulting in a more vertical profile and landward recession of the dune face. At survey site 3 the frontal dunes were overtopped by the storm tide and wave run-up, and there has been vertical erosion i.e. reduction in the height of the dune, and in some instances complete removal of the frontal dune (Fig. 10). Here also, dune swales behind the frontal dune have channelled the storm tide and this has probably exacerbated the erosion of the second and third rows of dunes (Figs 11 and 12). The dune swales here appear to have been colonised previously by mangroves, as dead mangrove stumps occur in the swale between the first and second rows of dunes. It is

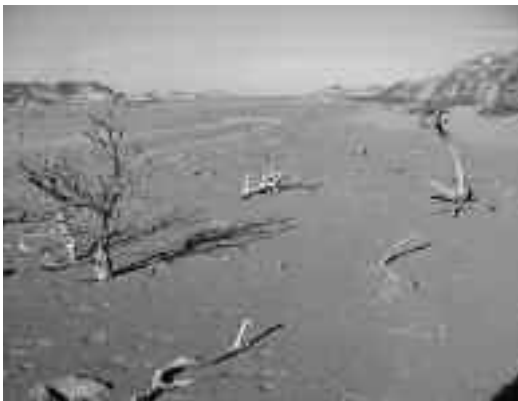
**Fig. 11** Erosion of second row of dunes by waters surging through interdune swale.

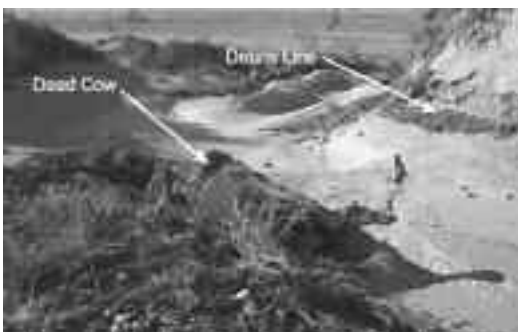
**Fig. 12** Erosion of third row of dunes. Note dead cow wedged in opening scoured by storm surge/tide.

Dead cows littered the beach along this entire section of coast. At all locations, except survey site 3, these cows lay seaward of the first row of dunes. At survey site 3 some of the cows were deposited amongst both the second and third rows of dunes. In one instance a cow was deposited in a narrow opening through the third row of dunes (Fig. 12). This opening appears to have been scoured, or at least enlarged, during the cyclone storm tide event, for an oblate shaped depression has been eroded into the sand floor at the mouth of the opening. Mud was eroded and transported from the swale between the first and second rows of dunes and deposited at the head of this opening well inland of the third row of dunes. The storm tide in this instance penetrated approximately 150 m inland beyond the position of the first row of dunes.
