Impact statistics of *Tracy* and an opportunity missed

R.H. Leicester¹ and G. Reardon²

When cyclone *Tracy* struck Darwin in 1974 it caused extensive damage to housing. A survey conducted by the authors included measurement of a damage index for about 1500 timber framed elevated houses of similar size and construction. This large sample provided a unique opportunity for quantifying the spatial variation of the wind-field impact of a typical tropical cyclone.

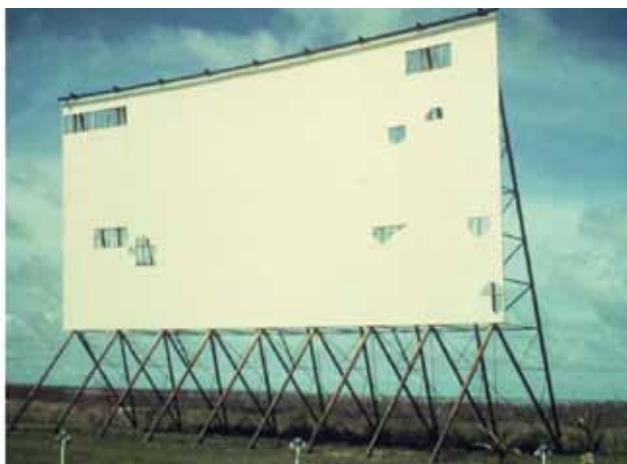
Fig. 7 Drive-in movie screen located in a northern suburb of Darwin.

The damage incurred by cyclone *Tracy* and subsequent experiences cited, indicate that the process of engineered cottage construction used in Australia cannot be relied on to produce houses that can reliably resist rare and extreme wind pressures such as those that occurred during the course of cyclone *Tracy*. The historical record of wind pressures in Darwin, as shown in Fig. 6, illustrates the difficulty of relying solely on past experience in design and construction to deal with rare loads. By contrast, conventionally engineered structures in Darwin, such as for example the steel framed drive-in screen shown in Fig. 7, performed perfectly.

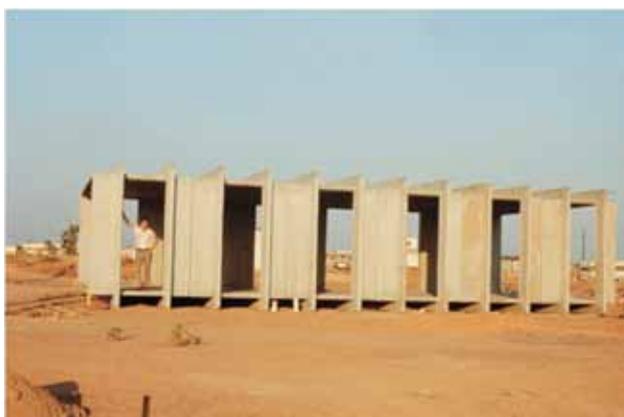
Fig. 9 Heavy reinforced concrete boxes act as excellent anchor structures.

The incorporation of a reliable anchor structure within a house can often be done with minimal extra cost. In fact there are some existing building systems that do have reasonably reliable anchor structures. These include heavy section welded steel frames, some reinforced concrete block systems and heavy pre-fabricated houses constructed with room size boxes of reinforced concrete (Fig. 9). However it would be fair to say that these systems contain anchor structures by accident rather than through deliberate design considerations.
