# East Coast Lows and the Pasha Bulker storm—lessons learned nine years on

Danielle C Verdon-Kidd,<sup>1\*</sup> Anthony S Kiem<sup>1,2</sup> and Garry R Willgoose<sup>3</sup>

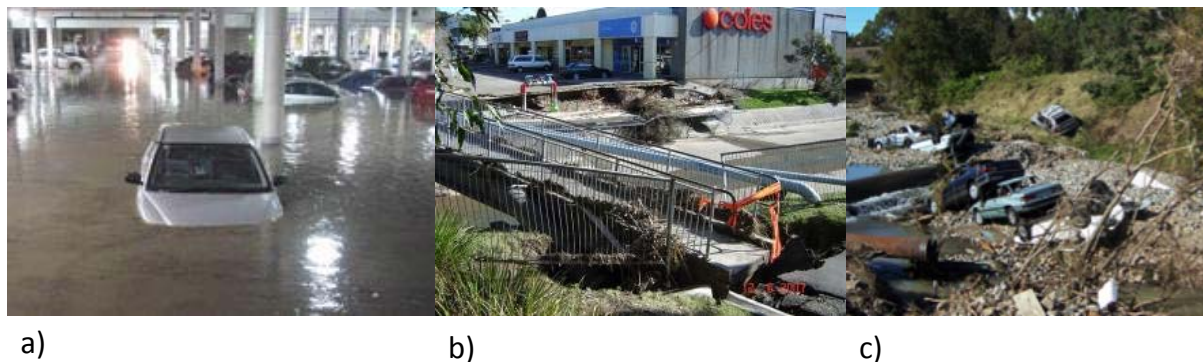
Figure 4 Flood damage (a) supermarket car park, (b) footbridge abutment, (c) car yard debris.

Cardiff Central Business District (CBD) in the Lake Macquarie Local Government Area (LGA) was greatly affected by the flooding, with an estimated \$2 million damage losses to business (Jones 2007). Commercial areas of Wallsend and Newcastle West (both Newcastle LGA) were also particularly hard hit (Figure 4) with premises inundated by up to 1.6 m of floodwater (BMT WBM, 2009). Evacuations of many properties, including Wallsend Plaza, were required at the peak of the event, increasing the level of personal risk. Flooding in Newcastle West was significantly worsened through blockage of culverts by shipping containers, which had been dislodged from nearby building sites (Carpenter 2007). For most areas, flooding came quickly and lasted less than an hour. Flood depths and velocities across overland flowpaths were high, and caused considerable traffic chaos as the event coincided with a Friday afternoon peak hour. Flood velocities were reported to be particularly high within the concrete-lined open channels—even the smaller drains in the upper catchments (BMT WBM 2009). In comparison, velocities were generally slower across overland flow paths. Floodwaters had sufficient force to dislodge a number of large concrete panels from within stormwater channels. Where floodwaters departed or re-entered a formal channel, the velocities mobilised footpath slabs and damage footings of some houses.

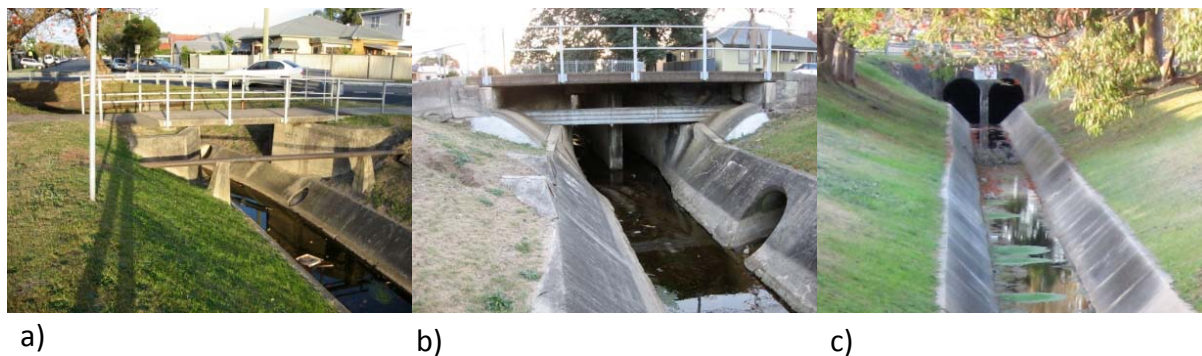
Figure 5 Stormwater system features that capture debris (a) low pipes below ground elevation, (b) pipes, telecommunications, and in-stream piers, and (c) open channel to culvert transitions.

A notable aspect of the interaction between the debris and the stormwater system in the Cottage Creek catchment was that (1) proceeding downstream there are numerous switches between open channel and narrow (narrower than the open channel) pipe entrances providing numerous points at which debris could block the stormwater system (2) numerous bridges with in-channel piers that reduce the channel opening significantly and these openings are of the size that a colourbond or cyclone-mesh panel can become entangled, and (3) numerous crossings of the open channel with pipes and other infrastructure at levels just above the 1 in 100 year flood level but below the surrounding ground level (Figure 5). All three characteristics provide ample opportunity for debris to block the storm water system. It is notable that current design recommendations (e.g. Australian Rainfall and Runoff (Pilgram 1987)) do not mention the potential role of urban debris in reducing flow cross-sections in stormwater systems (as compared with their recommendations for rural flooding). The most substantial blockage occurred at the downstream end of Cottage Creek, where shipping containers from nearby construction sites became lodged within culverts (Carpenter 2007). These particular blockages resulted in elevated water levels on the upstream side. The extent of exacerbation of flooding impacts resulting from the blocked drains was investigated using computer flood models (BMT WBM 2008). The Cottage Creek blockage was found to generate flood levels of up to a metre higher than normal through the Newcastle West business area, and up to 500 mm higher through Marketown Shopping Centre. Further, the damming effect caused by the containers meant that inundation persisted for many hours after the peak event, with water unable to drain out of the catchment.
