Bureau of Meteorology

Severe thunderstorm and tornado outbreak South Australia 28 September 2016

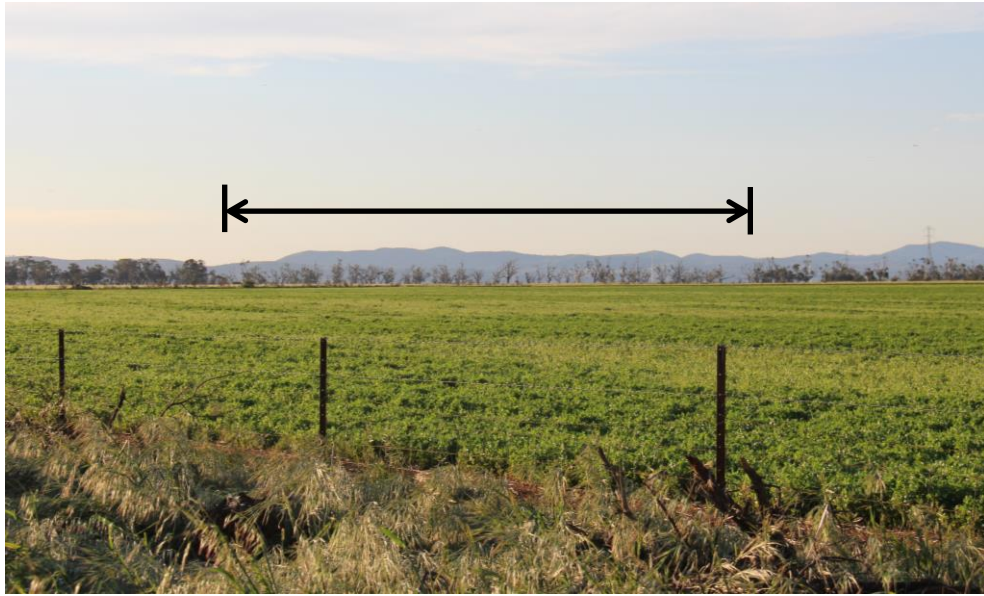
Figure 48: *Tornadic damage to trees along Spring Creek, nearby damage marker 4, indicates the approximate width of the Wilmington tornado.*

evidence the tornado is estimated to have started at approximately 03:45 pm and finished at 04:05 pm. This tornado has been rated at F2 strength, based on the damage indicators in table 4. The upper bound of wind speeds for damage markers 4, 5 and 6 reached the low end of the F3 scale, but a lack of supportive evidence of this wind speed from other damage indicators excludes a rating beyond F2. The wind speed estimates for this storm do however indicate that this was the strongest assessed tornado on the day and was likely at the upper end of F2. Damage to a section of trees along Spring Creek (Figure 48), nearby damage marker 4, gives a visual guide on the approximate width of the tornado at that point.

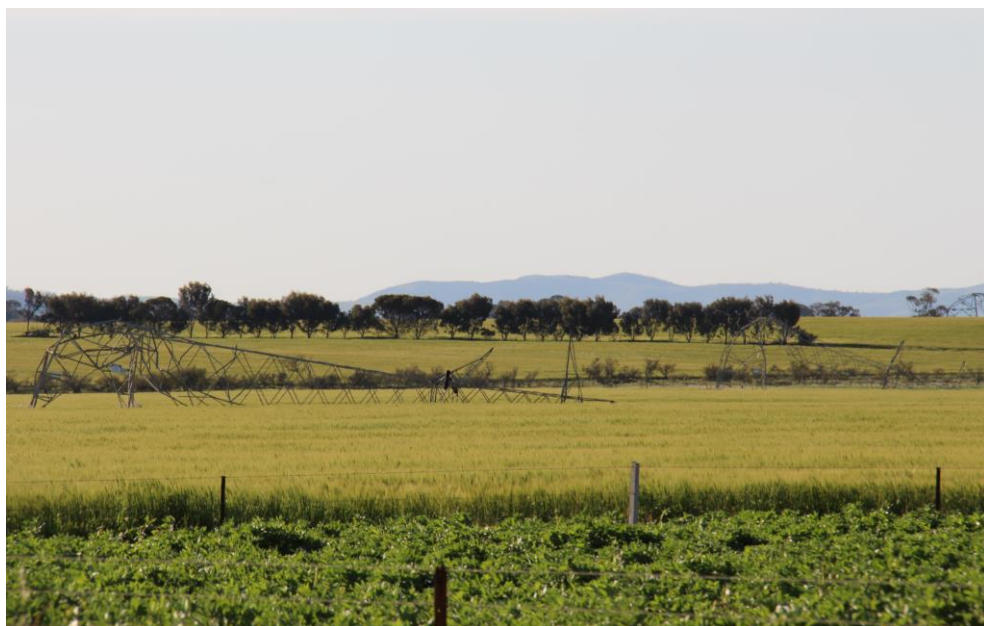
The Davenport - Brinkworth transmission line was also impacted by the supercell thunderstorm that produced the Wilmington tornado and damaged the Davenport - Belalie and Davenport - Mt Lock transmission lines. The preliminary AEMO report ^[3] suggests this damage occurred after the state-wide blackout. A total of 14 towers were damaged and these were located well to the south of the Wilmington tornado damage path. In the vicinity of the towers there was little evidence of significant damage to vegetation or structures, indicating that these towers were not directly impacted by a tornado. Figure 55 shows the damaged towers on the transmission line and was taken on Girdham Rd looking northwest with towers collapsed towards the northeast.

Figure 55: Damaged towers on the Davenport – Brinkworth transmission line
